Manhole Inspection Summary

Manhole # S43K__031MH

Insp Date: **6/3/08 2:42 PM**

Location Address: **502 s bethel st**

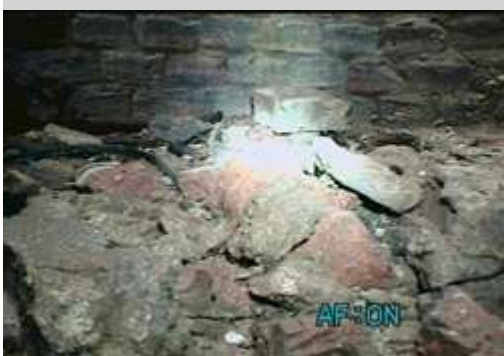
Defect 3

Condition: ☐ Sound ☐ Cracked ☐ Root Intrusion ☐ Deteriorated ☐ Leaks ☒ **Debris**

channel debris

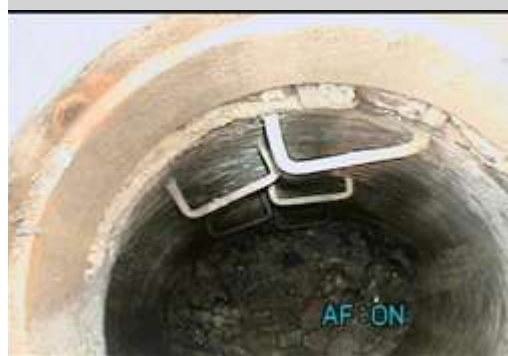
Defect 2

Count: **5** Missing: **0** ☒ **Corroded**

steps

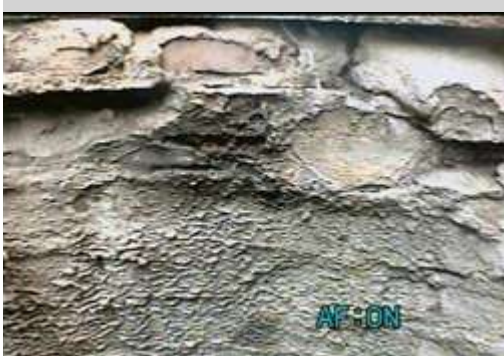
Defect 1

Condition: ☐ Sound ☐ Cracked ☐ Root Intrusion ☒ **Loose Brick** ☐ Deteriorated

loose bricks, frame adj

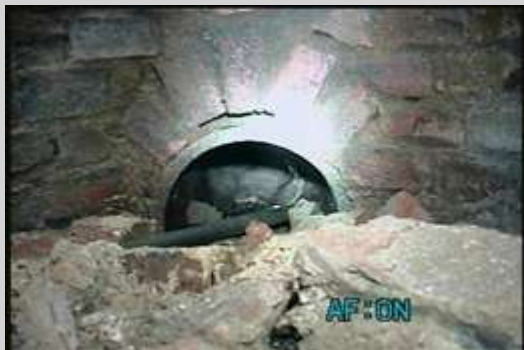
12 O'Clock Outflow

8 in. Circular Gravity Sewer
Pipe Out @ 12 O'Clock

Deposits: ☐ None ☐ Mud ☐ Sludge ☒ **Debris** ☐ Grease

Silt Depth: **3** (in.) Deposits Extent: **Medium**
